CHASMARS POND DAM CT 00059

PHASE I INSPECTION REPORT NATIONAL DAM INSPECTION PROGRAM

MAY 1981

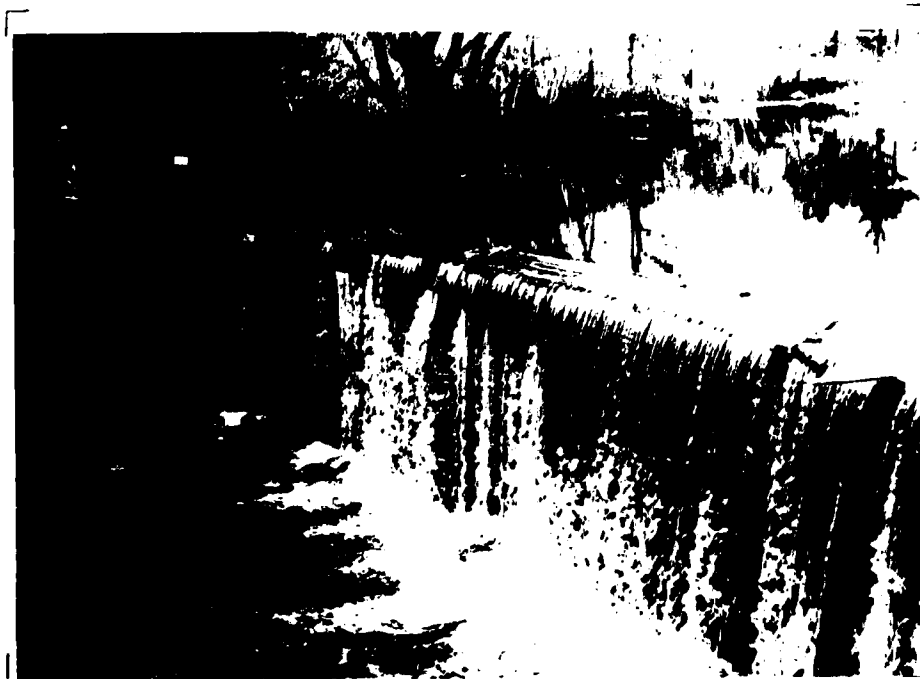
The masonry wing walls (Photos 1 and 2) form a transition channel between the dam and the railroad culvert. No signs of bulging or settlement of the walls were noted; however, a small, immeasurable amount of seepage was observed emanating from the mortar joints. In addition, several trees ranging from 2 to 8 inches in diameter and patches of brush were noted overhanging the transition channel.

There was a slight accumulation of debris on the spillway dam and in the transition channel (Photos 1, 2 and 3). In addition, several trees overhanging the transition channel were noted near the wing walls and above the large masonry culvert.

Photo 1 Dam, right wing wall at abutment, and transition channel.

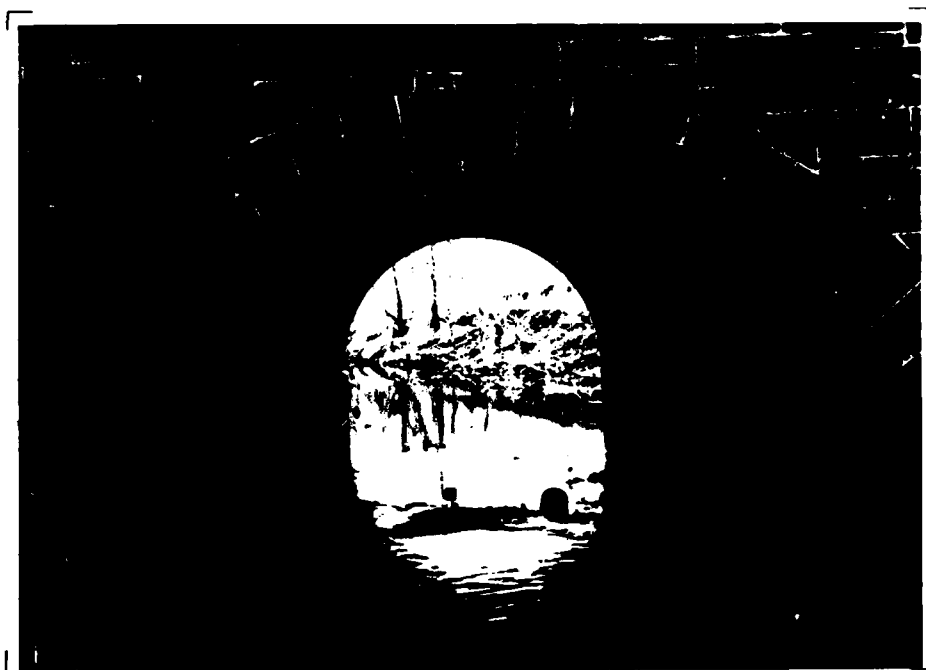
Photo 6 Brick lined railroad culvert. Note crude dike in background.
